## **MAINTENANCE OF OLKARIA 1 ADDITIONAL UNITS (AU) POWER PLANT, KENYA**

### **ABSTRACT**

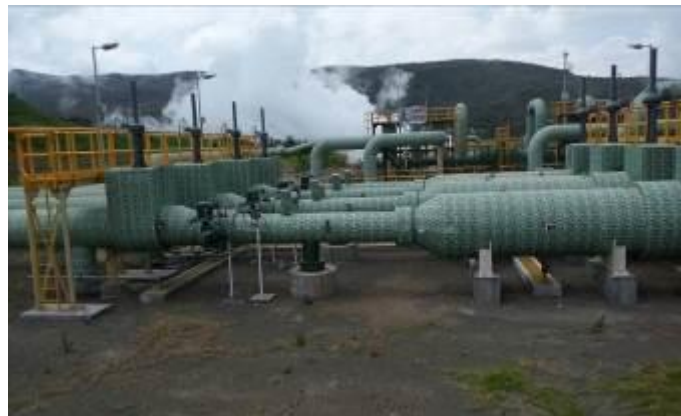
Prior to installation of this station, the wellhead pressures ranged from 6 to 9 barg while the separation pressures were 5.5 barg to give a turbine inlet pressure of 4.2 barg. After installation, the wellhead pressures ranged between 10 to 14 barg while the separation pressures are 10 barg to give a turbine inlet pressure of 4.2 barg. The station has special pressure control valves that carry out adiabatic expansion of the steam and maintain a high upstream steam field pressure and the desired downstream pressure at the plant. Maintenance is mainly carried out on stuck pressure control valves which are Fisher and Rotork type.

Figure 5: Pressure control valves

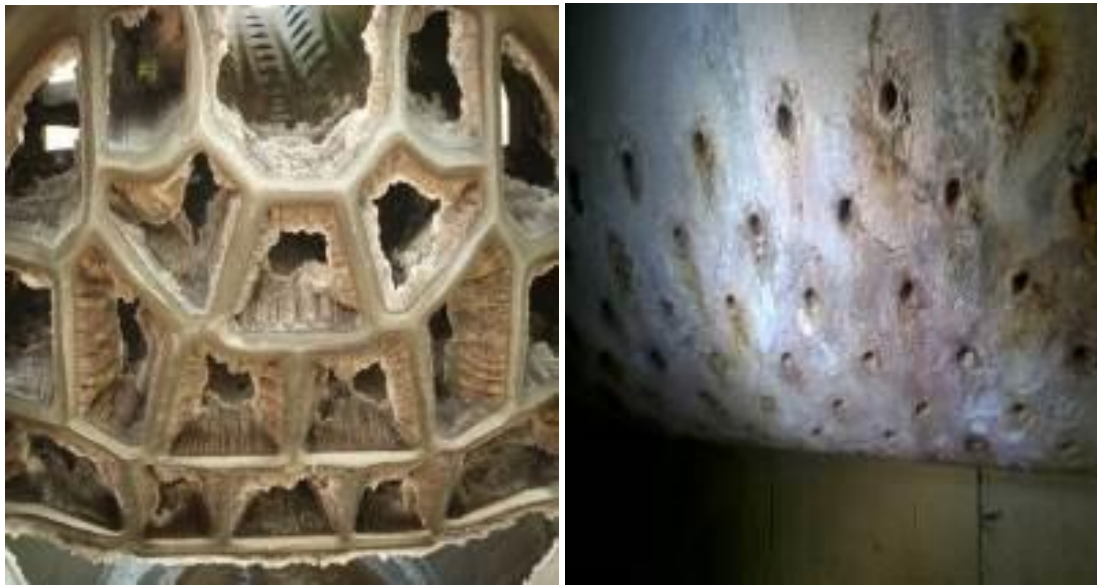
The vent valves are ball butterfly (Fisher) type and are designed to handle a total of 1046 T/hr of steam. Maintenance at this station is mainly carried out on the valves, condensate drain ports and diffusers. The valves are stroked and calibrated while condensate drain ports and diffusers unblocked and cleaned. The Figure 6 below shows pictures of a clogged flow control valve and diffuser taken during the plant annual inspection in January this year.

Figure 6: Clogged vent valve and diffuser

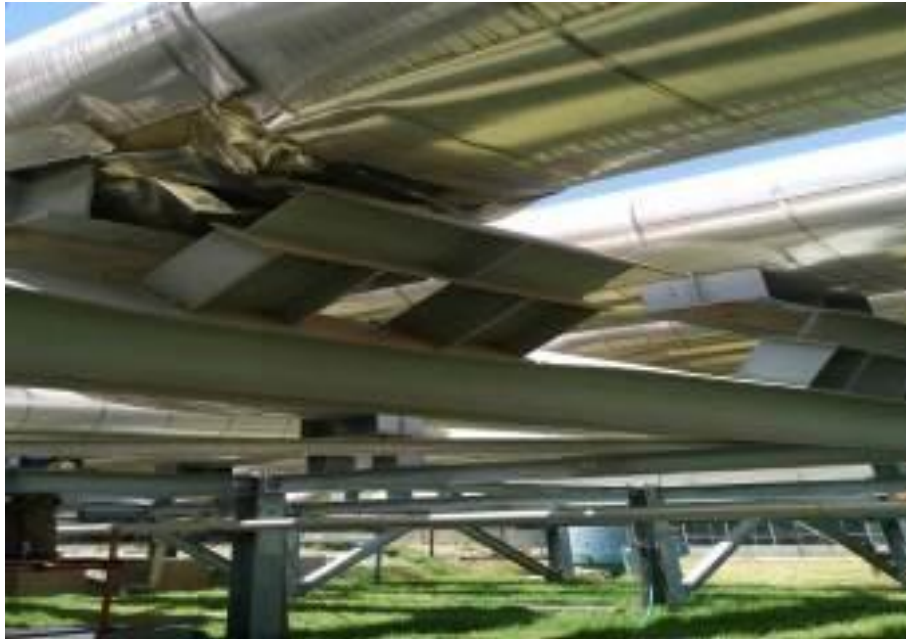
Slug flow is intermittent flow caused by a moving liquid bubble mass being pushed by a gaseous mass. In March 2016, this phenomenon occurred in Unit 4 resulting in deflection of steam line support structures as shown in Figure 7. The damaged structures were repaired and reinforced. To avoid such scenarios in future, it was resolved that frequent monitoring of clogged steam drains must be undertaken so as to unblock them before starting up the plant.

Figure 7: Deflected main steam line supports

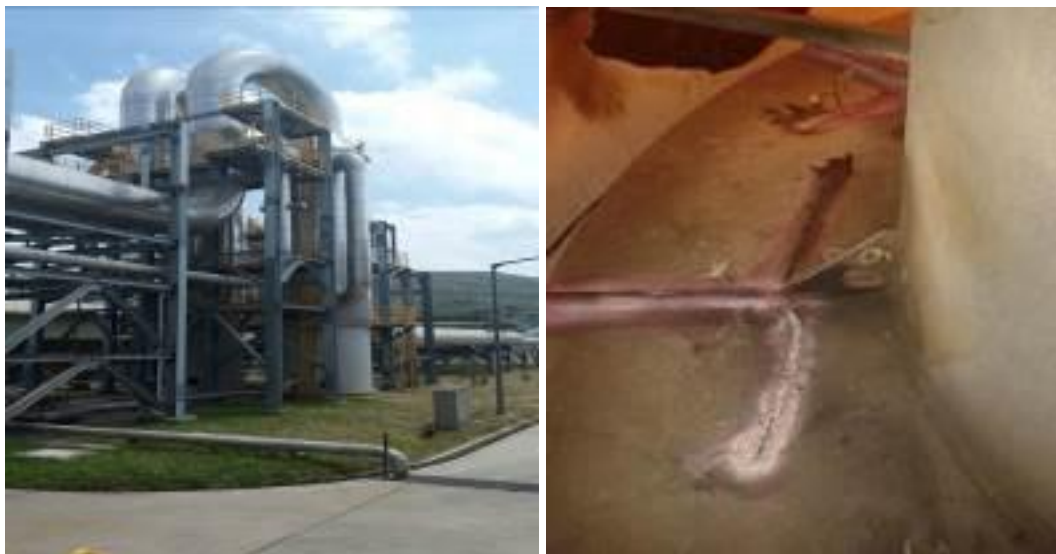
The steam scrubbers provide 99.98% dry steam to the turbine. They are cyclonic separator type and have less than 0.1 barg pressure drop at rated conditions. They are equipped with a waste condensate vessel where the condensate separated is collected temporarily before being discharged to the cooling tower through spargers. The discharge is enabled by drain valves. Carryover from the separators due to an unreceptive hot reinjection well led to frequent clogging of these drain valves thus initiating turbine trips due to high condensate levels in the scrubber. Scale pellets were cleaned from the drain valves. In November 2014 Unit 4 and Unit 5 scrubbers developed internal abnormal noises leading to cracks in the vortex tube and smoothing sleeve weld seam. This was considered a design failure which was rectified by the EPC contractor.

Figure 8: Steam scrubber and internal repairs

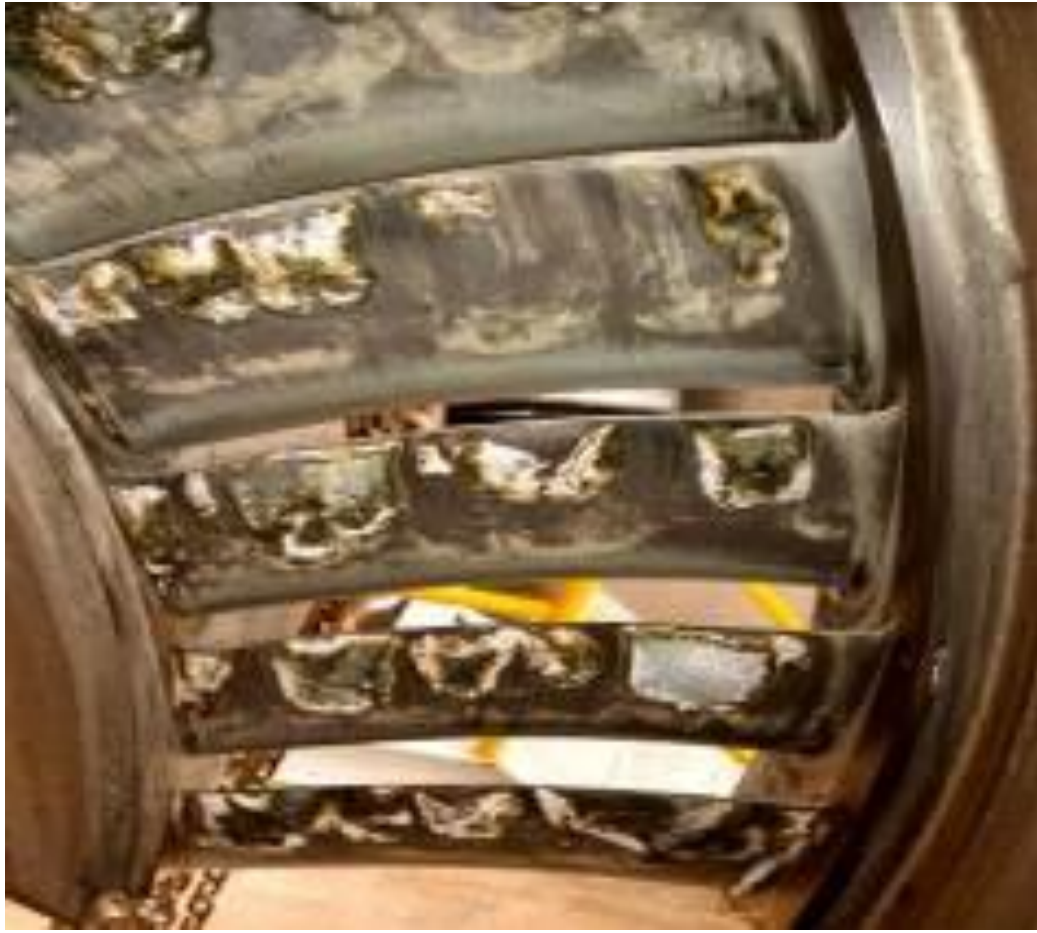
The turbine has supervisory and monitoring instruments for temperature, speed, eccentricity, differential expansion and vibration thus enhancing condition based monitoring and maintenance. The turbine also has lead ways which decreases the condensed steam in the turbine which wears the turbine blades. During commissioning steam pressure drops between the 1<sup>st</sup> and 2<sup>nd</sup> stage steam turbine nozzles were experienced leading to onsite nozzle clearance enlargement by Toshiba. At end of defect liability inspection, the turbine was disassembled and scaling found in the 1<sup>st</sup> stage nozzles as shown in Figure 10. This was attributed to the unreceptive hot reinjection Well 13 leading to carry over from the separators into the plant. The scaling was cleaned and the turbine reassembled.

Figure 10: 1<sup>st</sup> stage stationary nozzle silica scaling

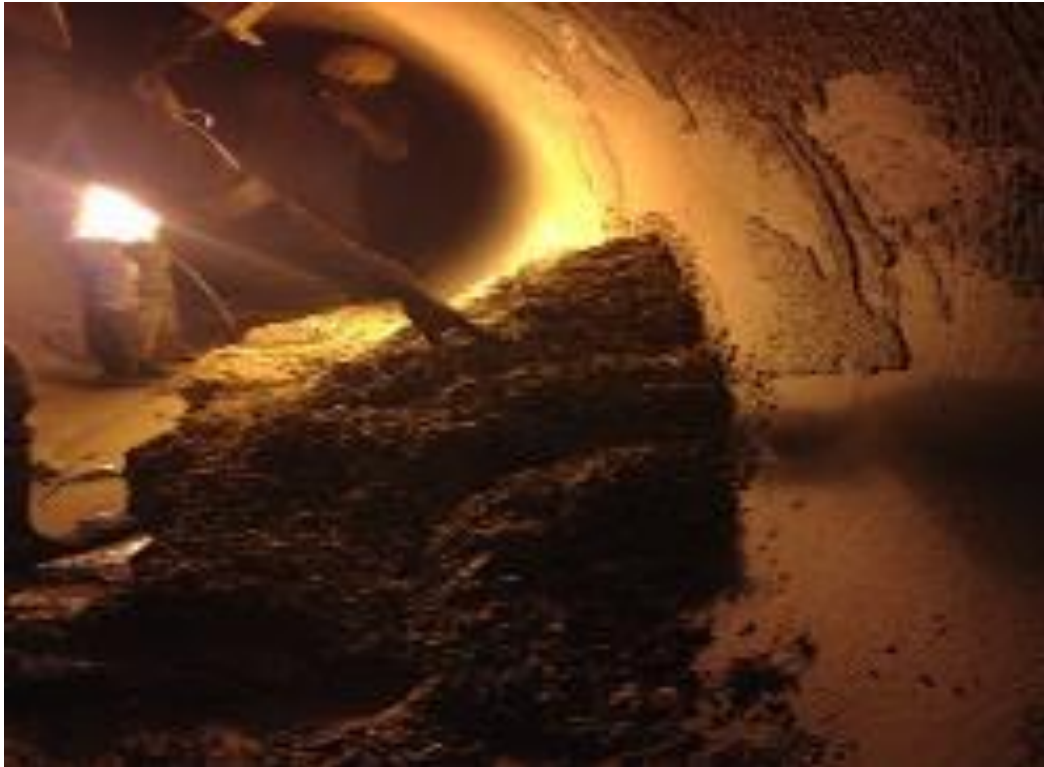
Olkaria 1AU has two cooling towers. They are counter flow induced draft type with 8 cells per tower. The inlet water flow rate is 17520m<sup>3</sup>/h with a wet bulb temperature of 18°C including recirculation. Cooling tower water is regularly treated, generally with biocide and dispersants, to prevent the growth of harmful bacteria, minimize corrosion, and inhibit the build-up of scale on the fill. The plant uses condensate as make up water which can cause scaling. The internals are film fills designed for a maximum TSS <150ppm. During annual inspection, the films fills were disintegrated as there were many loose sheets, large holes in the pack randomly distributed throughout the cells due to failure of the adhesive that binds each individual sheet into blocks. The spray nozzles were clogged.

Figure 11: Deposit of foreign material in the cooling tower GRP pipe

The nozzles and pipes were cleaned. The film packs used by the EPC contractor were substandard and will be replaced in due course.

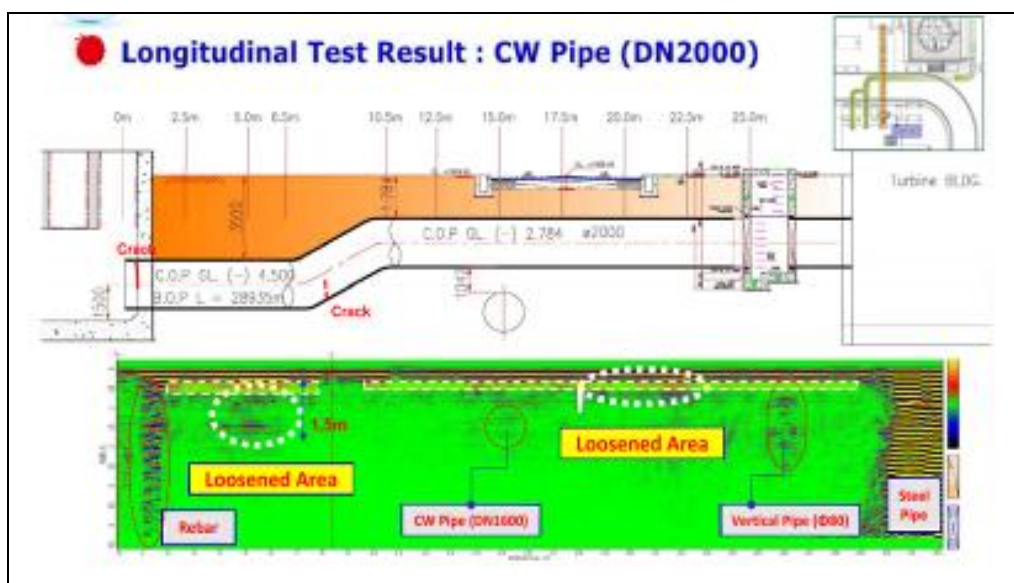
Figure 22: GRP longitudinal test results

Olkaria 1AU uses glass reinforced plastics (GRP) in the outdoor circulating water system. GRP is preferred because it is high corrosion and abrasion resistant, has a leak tight system for maximum loss free flow and also is cheaper compared to stainless steel. Olkaria generally has soils with near zero cohesion. This normally requires stricter considerations when compacting or an operation environment where the moisture content of the pipe surrounding is controlled and monitored on continuous basis. The 2000mm GRP return pipe from Unit 5 cooling tower to condenser developed cracks which was noted after water from a faulty scrubber drain sipped into the hotwell pit area.

The GRP pipe sand bedding was washed out causing pipe differential settlement. To ascertain the effect of the leakage on the general area, Geophysical surveys, ground penetration and electrical resistivity tests were done as shown in Figure 12. These tests confirmed poor consolidation as a result of the water ingress and grout injection was the available remedy for reinforcement of the sand bedding of pipe and the general area. This was done using low pressurized mortar. KenGen is considering encasing the GRP pipes in concrete and in other areas, using stainless steel pipes in ducts.
