MAINTENANCE OF OLKARIA 1 ADDITIONAL UNITS (AU) POWER PLANT

ARGEO-C6 CONFERENCE : 31ST OCTOBER - 4TH NOVEMBER 2016
ADDIS ABABA (ETHIOPIA)

Presented by: GEORGE NGOMI
MECHANICAL ENGINEER (POWER PLANT)

Kenya Electricity Generating Company Ltd
31st October – 4th November, 2016

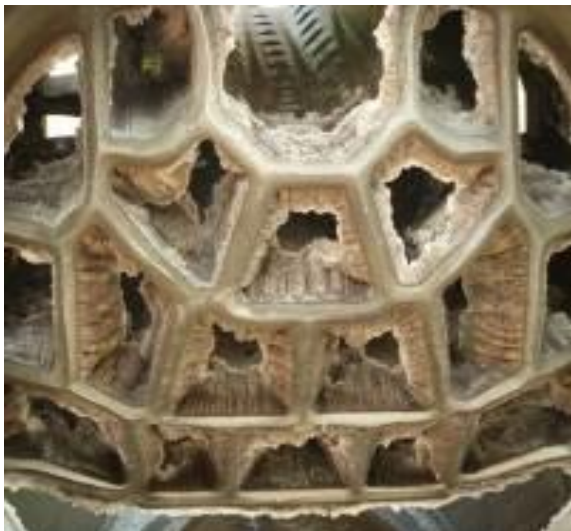
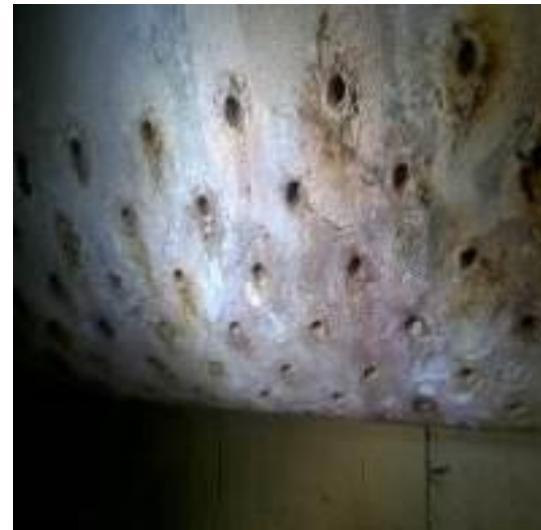
Vent Valves: The vent valves are ball butterfly (Fisher) type and are designed to handle a total of 1046 T/hr of steam. In January this year during annual inspection, the flow control valves and diffusers were found to be clogged after a very brief period of operation.

Valves: The valves are frequently stroked and calibrated while condensate drain ports and diffusers unblocked and cleaned.

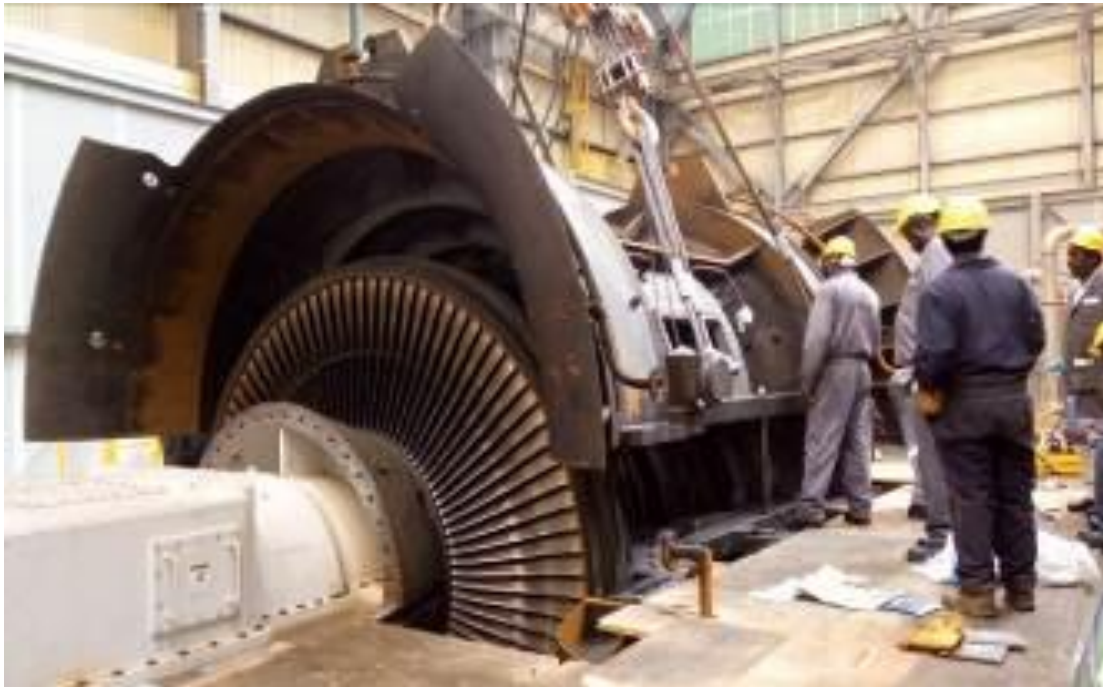
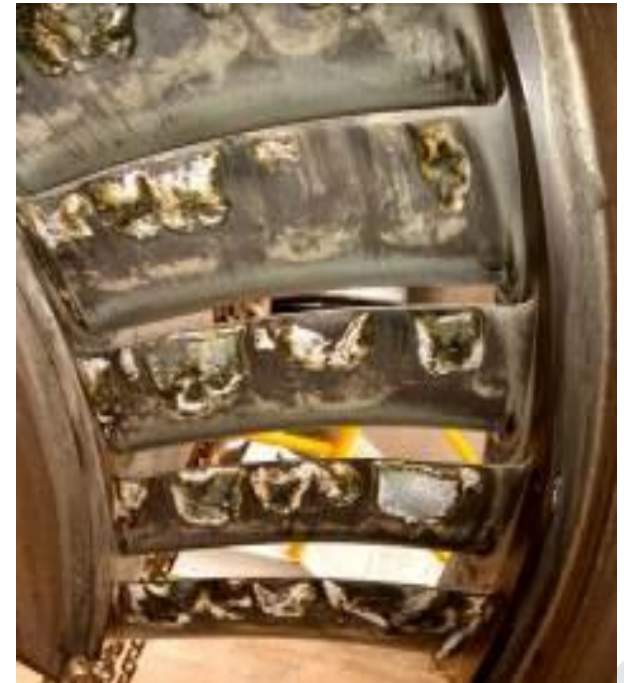
Steam Turbine: During commissioning, significant steam pressure drops between the 1st and 2nd stage steam turbine nozzles were experienced leading to onsite nozzle clearance enlargement by the OEM. At end of defect liability inspection, the turbine was disassembled and scaling found in the 1st stage nozzles. This was attributed to the unreceptive hot reinjection Well 13 leading to carry over from the separators into the plant.

Steam Turbine: The OEM disassembled the 1st stage nozzles and modified them on site.

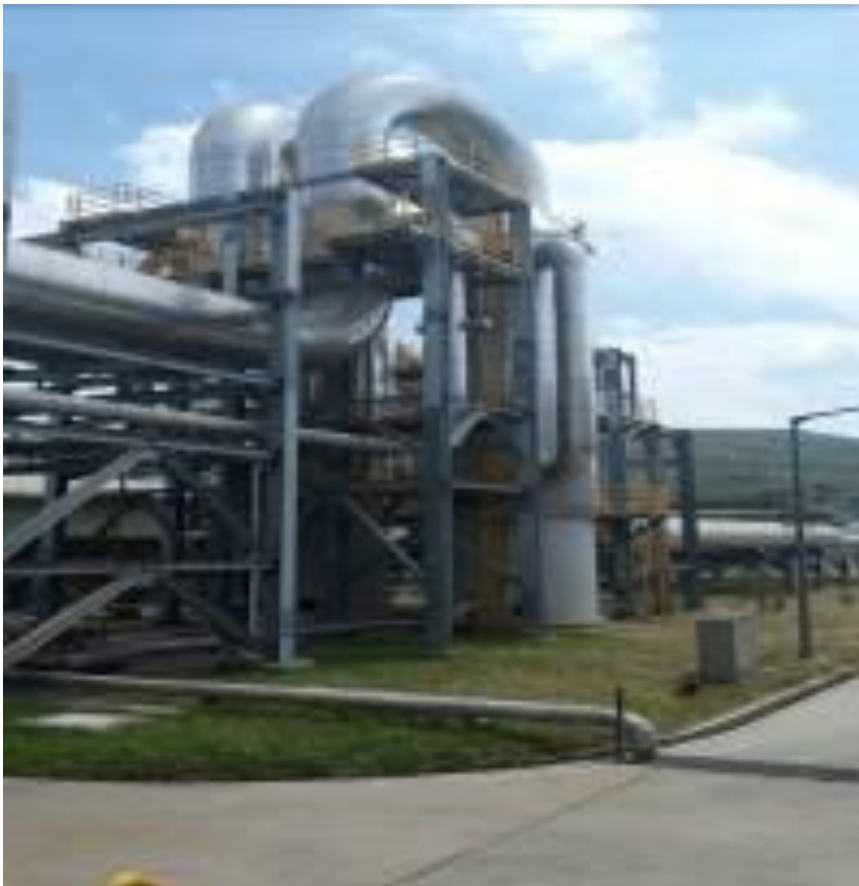
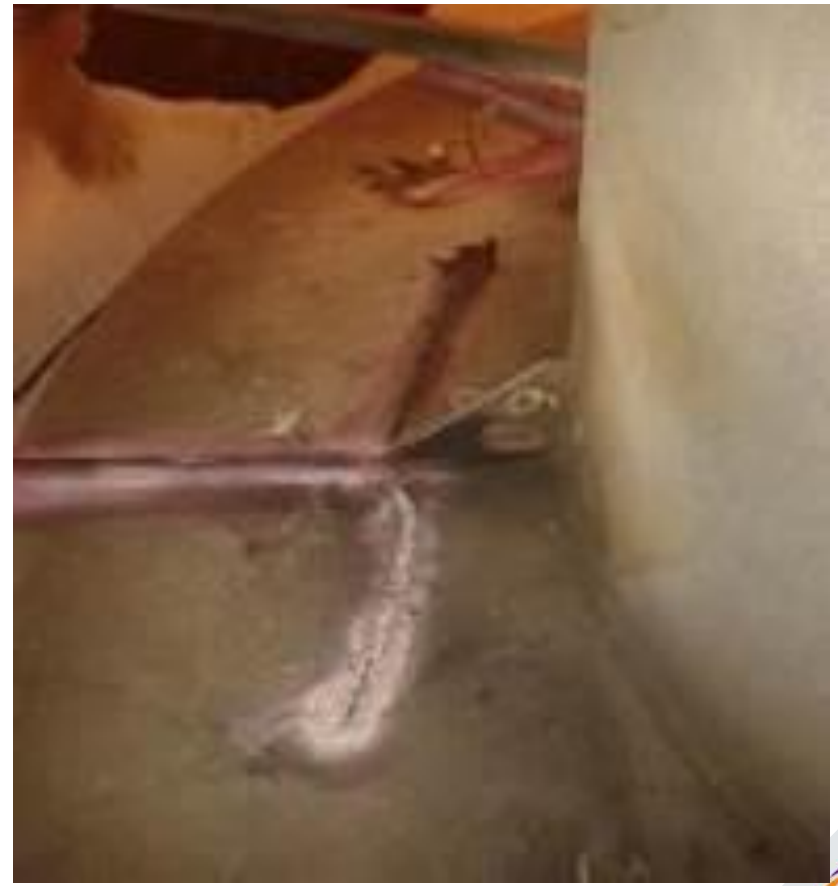
Scrubber: Cyclonic type. Frequent drain valve clogging due to carry over initiated turbine trips. Later, the scrubber developed internal abnormal noises leading to cracks in the vortex tube and smoothing sleeve weld seam.

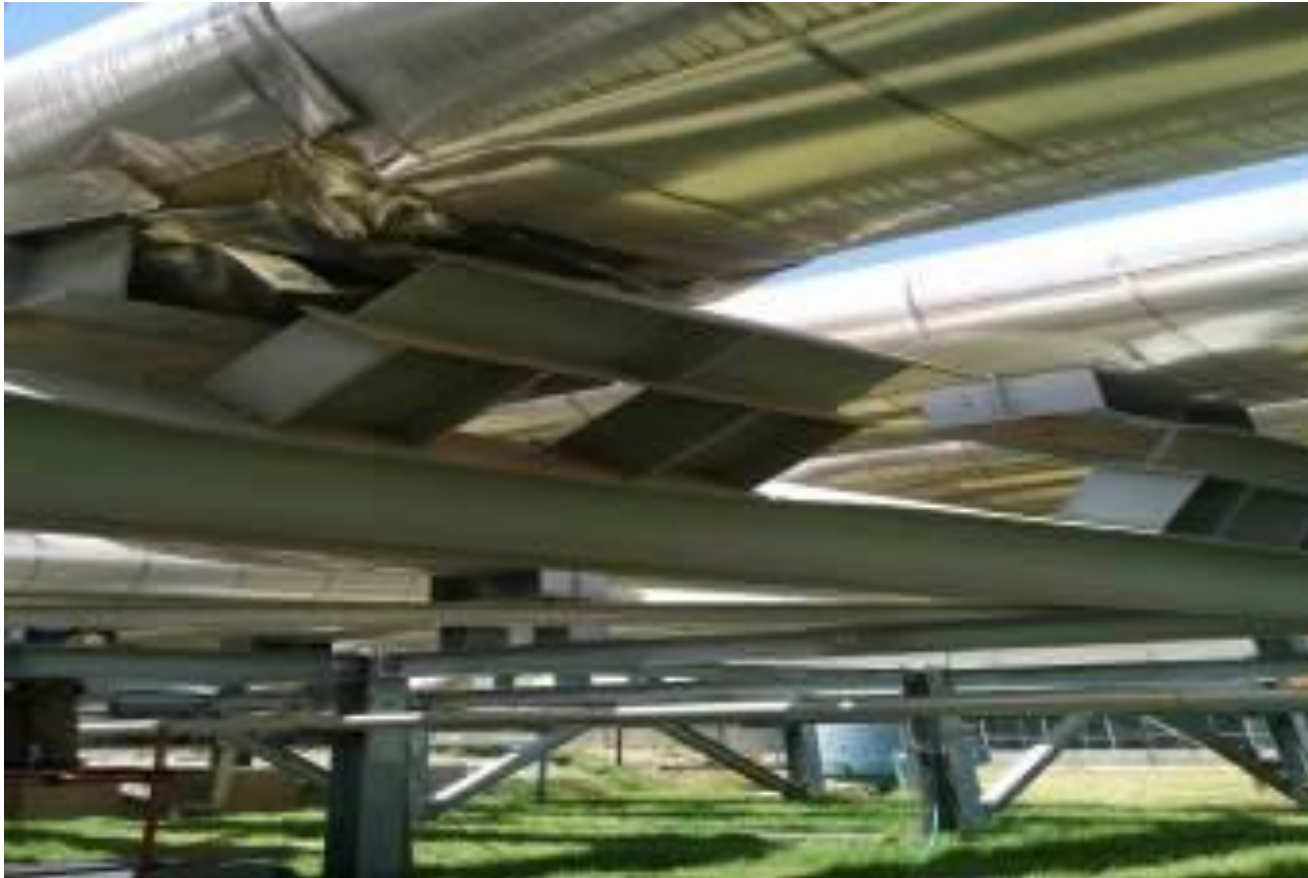
Steam Pipework: In March 2016, Unit 4 main steam line pipes were found to be deflected. This was attributed to clogged drain valves.

Main Steam Line : So as to ensure continuous operation, the Steam field team carries out *weekly routine checks*. The deflected pipe work at the power station was repaired and reinforced. To avoid such scenarios in future, it was resolved and documented that *frequent monitoring of clogged steam drains* must be undertaken so as to unblock them before starting up the plant.

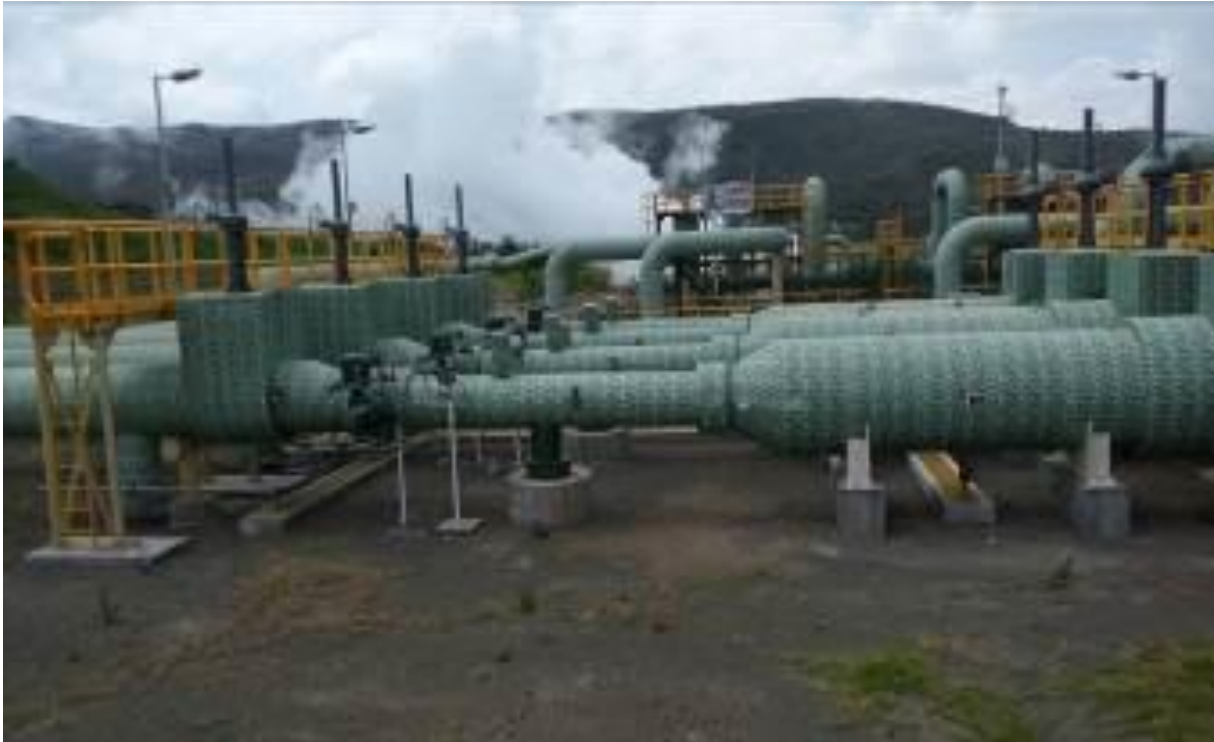
Pressure Let Down Station: PLDS was installed between 29th May and 14th June 2015 so as to operate the wells at high pressures i.e. wellhead pressures of 10-14barg and separating at 10barg. It was preferred because at the time, it was *least cost intensive* and would be used on a temporary basis as other options are considered in future. Maintenance is mainly carried out on stuck pressure control valves.

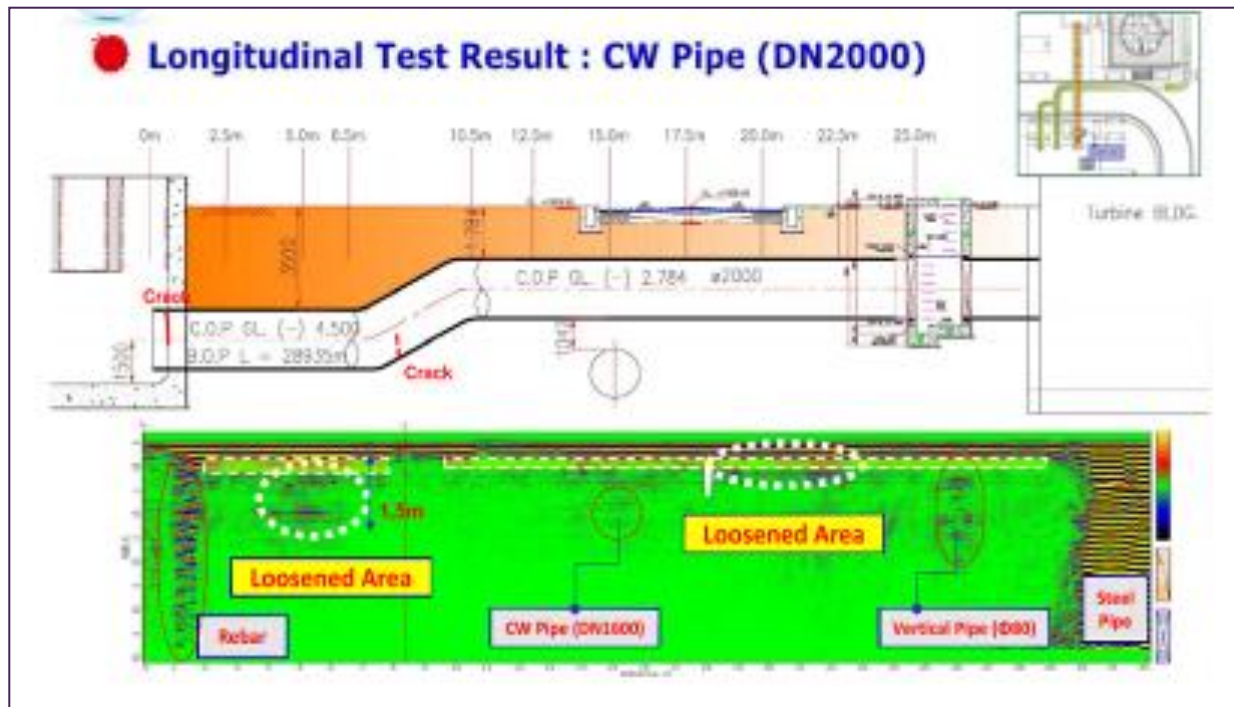
GRP : To ascertain the effect of the leakage on the general area, *Geophysical surveys, ground penetration and electrical resistivity tests* were done. These tests confirmed *poor consolidation* as a result of the water ingress and grout injection was the available remedy for reinforcement of the sand bedding of pipe and the general area. This was done using low pressurized mortar. KenGen is considering encasing the GRP pipes in concrete and in other areas, using stainless steel pipes in ducts.

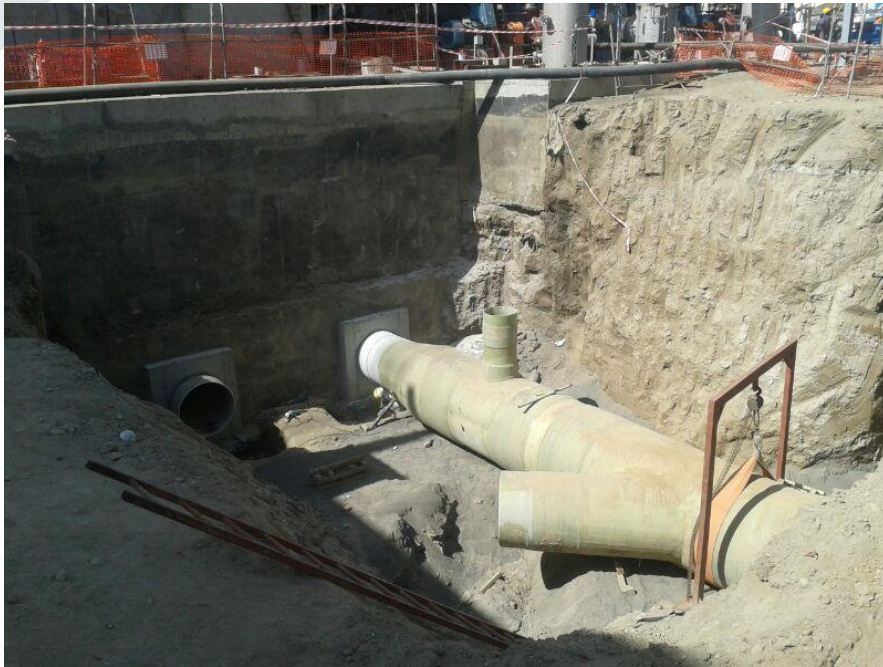
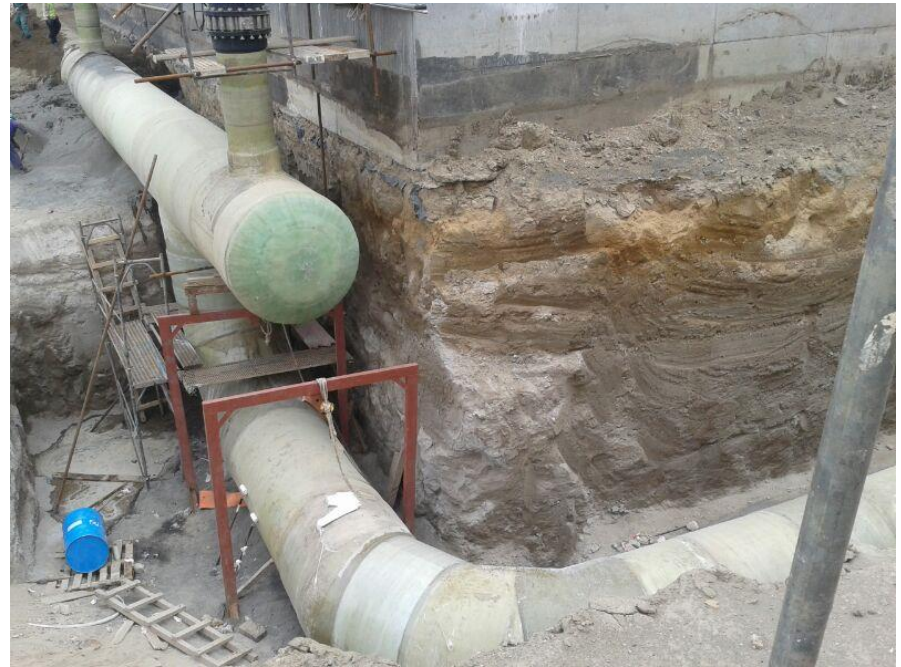
Recently, we had leakage of circulating water in Unit 4 1100mm & 1600mm GRP. Further investigation indicated poor compaction during construction. The pipes cracks were laminated.
