## **MAINTENANCE OF OLKARIA 1 ADDITIONAL UNITS (AU) POWER PLANT, KENYA**

### **ABSTRACT**

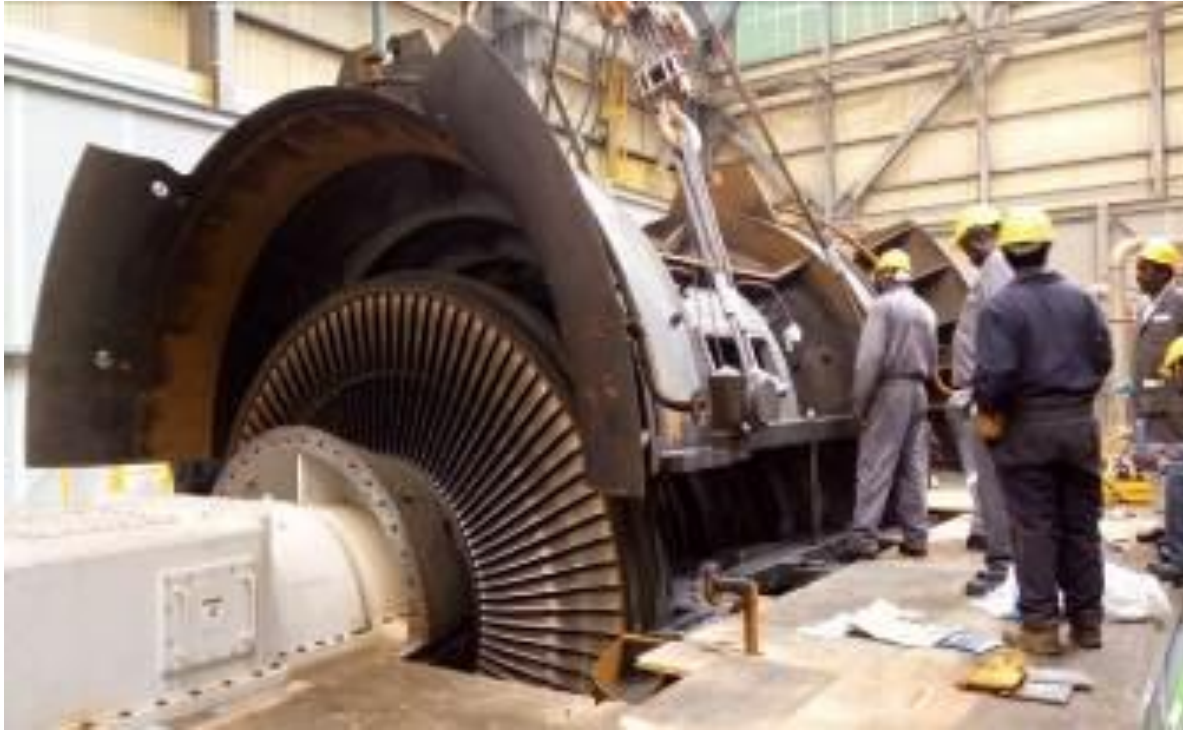
Figure 9: Steam turbine inspection

The turbine has supervisory and monitoring instruments for temperature, speed, eccentricity, differential expansion and vibration thus enhancing condition based monitoring and maintenance. The turbine also has lead ways which decreases the condensed steam in the turbine which wears the turbine blades. During commissioning steam pressure drops between the 1<sup>st</sup> and 2<sup>nd</sup> stage steam turbine nozzles were experienced leading to onsite nozzle clearance enlargement by Toshiba. At end of defect liability inspection, the turbine was disassembled and scaling found in the 1<sup>st</sup> stage nozzles as shown in Figure 10. This was attributed to the unreceptive hot reinjection Well 13 leading to carry over from the separators into the plant. The scaling was cleaned and the turbine reassembled.
