MAINTENANCE OF OLKARIA 1 ADDITIONAL UNITS (AU) POWER PLANT

ARGEO-C6 CONFERENCE : 31ST OCTOBER - 4TH NOVEMBER 2016
ADDIS ABABA (ETHIOPIA)

Presented by: GEORGE NGOMI
MECHANICAL ENGINEER (POWER PLANT)

Kenya Electricity Generating Company Ltd
31st October – 4th November, 2016

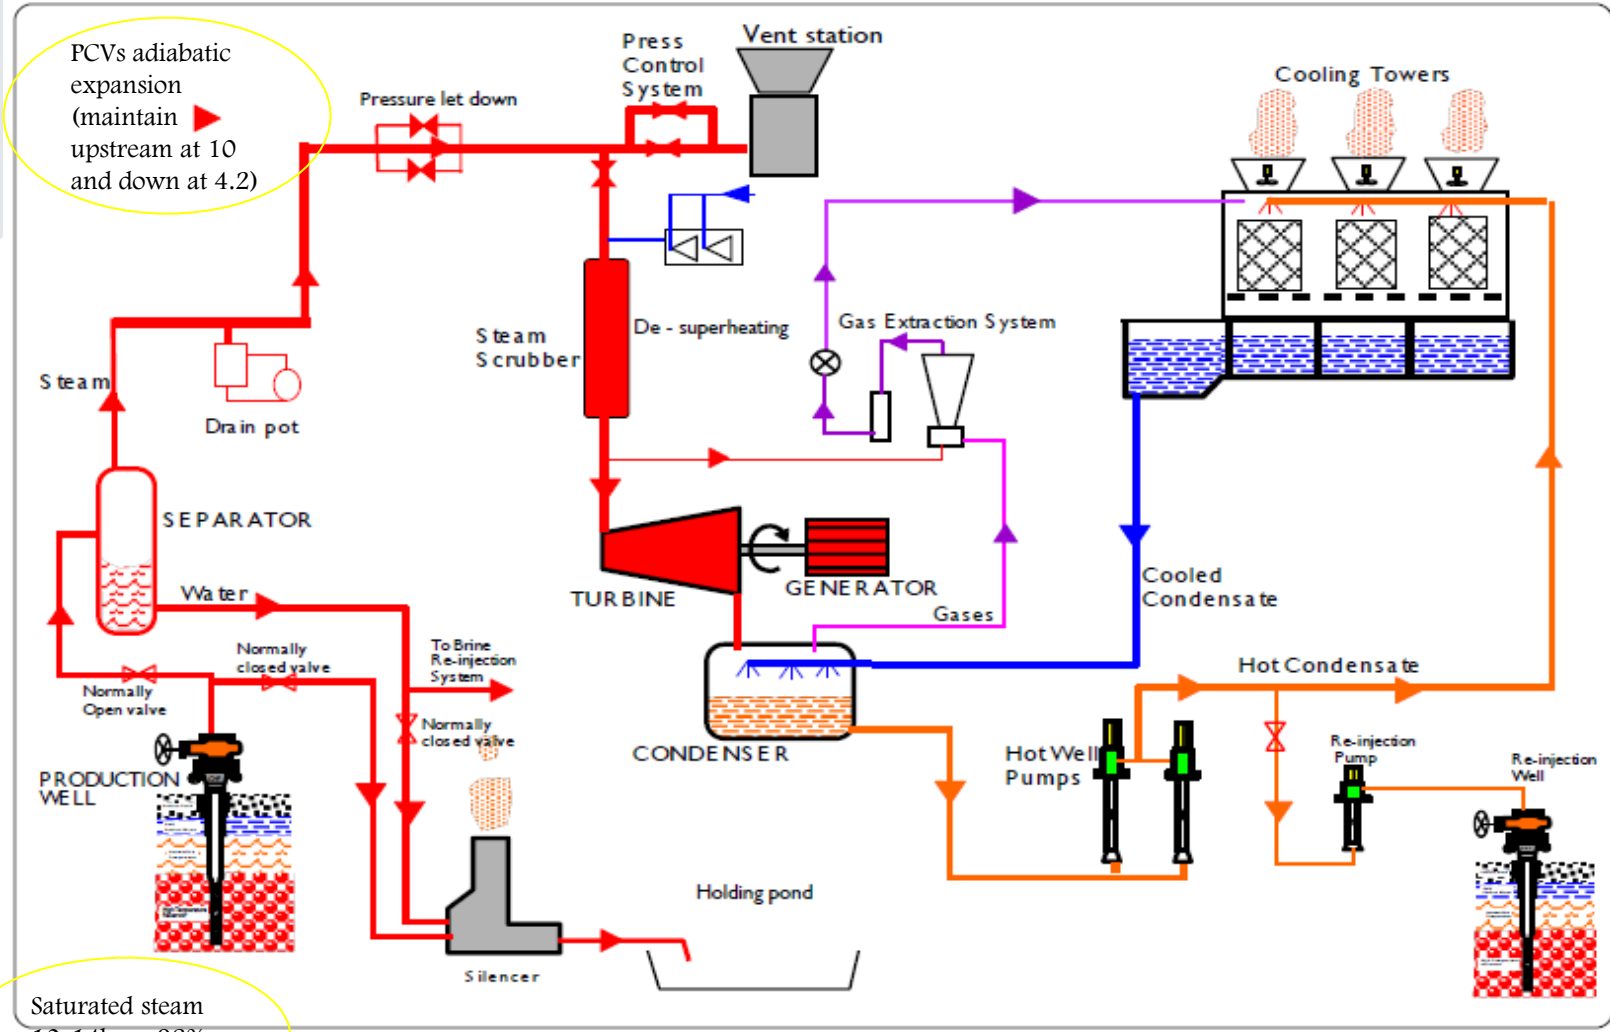
Steam Flow Diagram

PCVs adiabatic expansion (maintain upstream at 10 and down at 4.2)

Saturated steam 10-14 barg; 98% dryness
